**Circular From UK  
Date: 25 October 2017**

## **Nickel Ore Liquefaction**

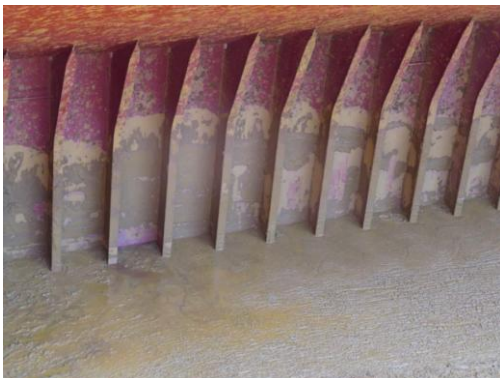
At the UK Club we are at the same time dealing with two ongoing cases in which cargoes of nickel ore from Surigao, Philippines have liquefied. In the first case, the crew noticed the ship was developing a list of 2 degrees and took immediate actions to reduce vibration and weather impact by adjusting course and speed. Upon arrival at the discharge port in China, the cargo in 3 out of 5 cargo holds was found to have liquefied - there were tide marks on both sides of the holds, and the master reported that the cargo had been flowing from side to side like wet cement in synchronism with the ship's rolling. Below is a picture taken from inside one of the holds. The other ship reported liquefaction in at least one of the holds part way through the voyage, and has headed for a port of refuge. The shippers in those cases were 'Century Peak Corporation' and 'Platinum Group Metal Corp'.

The Club wishes to remind Members that Group A Cargos of the IMSBC code prove a real and present danger to the stability of the ship if allowed to liquefy as the free surface flow effect will increase the Vertical Centre of Gravity of the ship and can cause the ship to capsize with little or no warning. As such, the Club wishes to remind Members that as per the attached circular they are required to notify the Managers if they intend to load a cargo of nickel ore as early as possible before loading commences.
