**Circular From SHIPOWNERS****Date: 4 February 2021****Case Study: Fall Into Cargo Hold Results In Fatality**

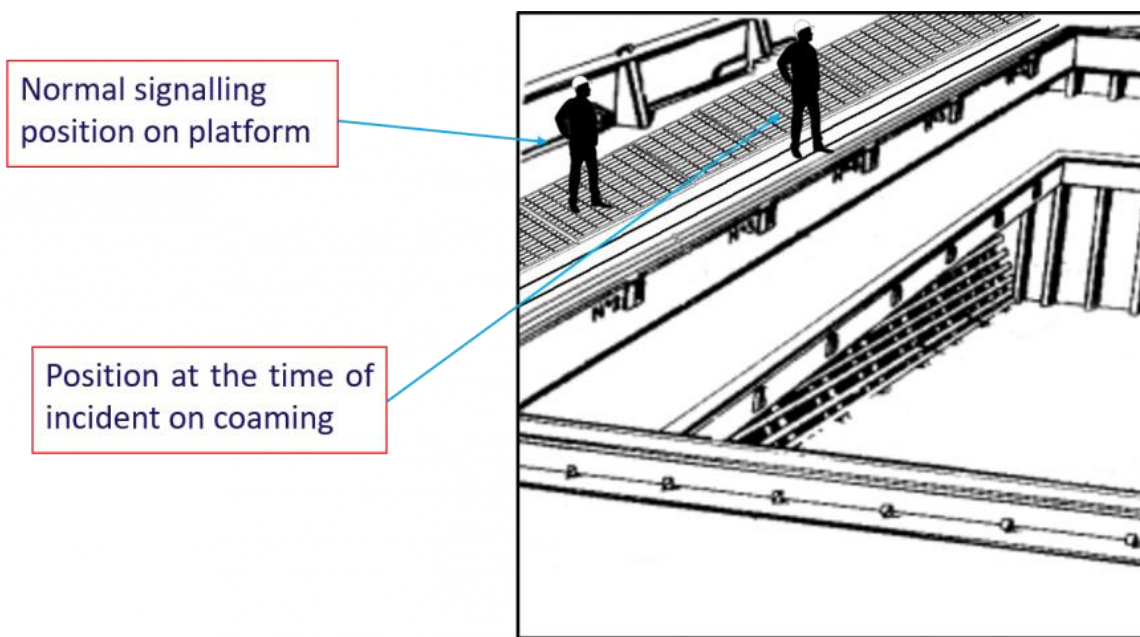
At approximately 2200hrs, the six crew members in the cargo hold heard a loud thud and discovered the supervisor lying on his stomach in the cargo hold with blood around his face. It is understood that he had lost his balance whilst on the hatch coaming and fell 12 metres into the cargo hold below. The crew member sustained severe injuries in the fall and was later pronounced dead.

- The decks were all reported to be dry at the prevailing time.
- There were no safety rails, nets or stanchions rigged around the cargo hold.
- There was a platform/passageway around the cargo hold that was supposed to be used to observe the cargo operations in the hold. Unfortunately, the crew member stationed himself on the hatch coaming to oversee the loading operation. In this location there were no preventative measures in place to stop him from falling into the hold.

1. **Marking of observation areas/signalling areas:** Dedicated observation/signalling areas should be clearly marked and highlighted. These areas should be positioned so that supervision of the prevailing operation, including actions such as signalling to the crane operator can be carried out safely whilst also maintaining a safe distance from the edges of the cargo hold away from any slip/trip hazards.

2. **Placing removable stanchions with guard ropes:** Hatch coamings of most vessels are designed to allow safety stanchions to be inserted. This enables a safety rope/chain to be installed around the open hatch to assist in preventing accidental falls into the hold. Where such an arrangement exists, crew must be adequately briefed to ensure that these are always put in place as soon as the hatch covers are opened. On vessels where such arrangements do not exist per design, a suitable risk assessment should be carried out to install a temporary safety rail to guard the open hatch coaming. If this risk is identified, consideration should be given for the fabrication of a safety rail system.
