**Circular From BRITANNIA****Date: 18 June 2021****Fatal Crush Incident**

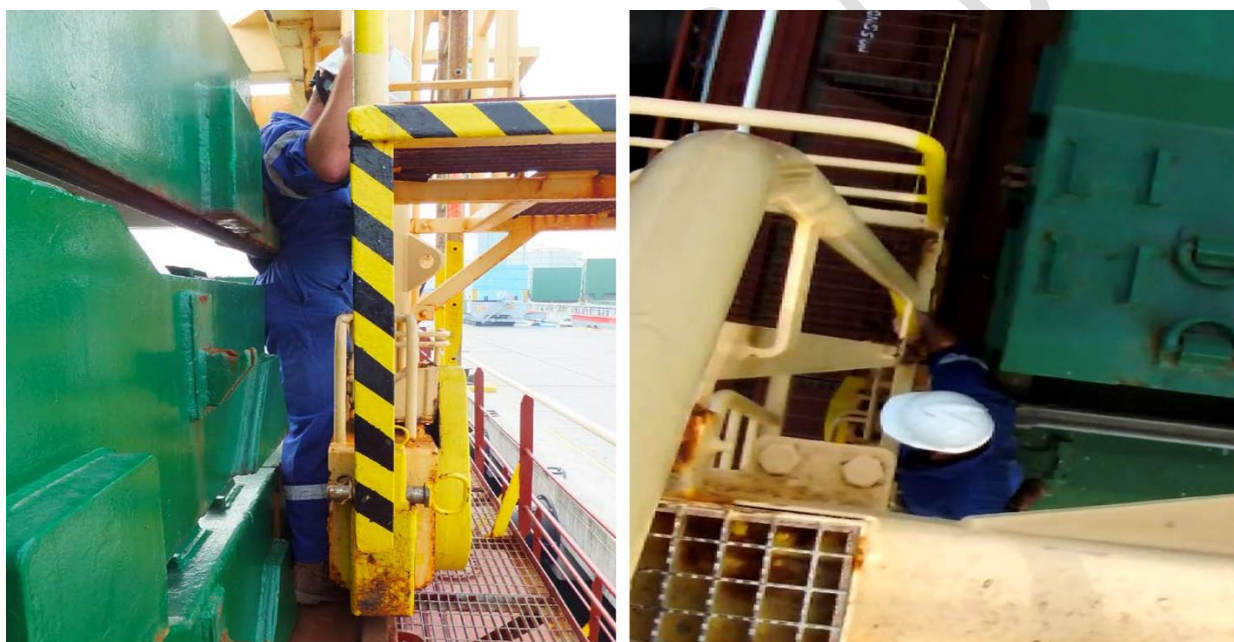
THE SECOND OFFICER (2/O) ON A GENERAL CARGO SHIP WAS FATALLY INJURED WHEN HE WAS CRUSHED BETWEEN THE SHIP'S GANTRY CRANE AND A STACK OF CARGO HOLD HATCH COVERS (FIGURE 1) DURING POST-CARGO LOADING OPERATIONS WHILE ALONGSIDE IN PORT. THE 2/O WAS ATTEMPTING TO PASS BETWEEN THE HATCH COVERS AND THE STATIONARY CRANE ON THE MAIN DECK, WHEN THE CHIEF OFFICER (C/O) DROVE THE CRANE AFT, TRAPPING AND CRUSHING THE 2/O AGAINST THE HATCH COVERS.

**FIGURE 1** RECONSTRUCTION SHOWING A CREW MEMBER IN THE GAP BETWEEN THE LADDER PLATFORM AND STACKED HATCH COVERS.

As he stepped towards the gap between the crane and the stacked hatch covers, the lifting bar cleared the hatch cover stack and the C/O drove the crane aft. The 2/O screamed as he was trapped and crushed between the hatch covers and the crane's ladder access platform (Figure 1).

The investigation noted that an emergency stop button was fitted to the crane platform, but the 2/O would have been unable to reach this while in the gap between the platform and covers.

- The crane's deck level emergency stop buttons could only be operated from the walkways and could not be reached by the 2/O before and after he became trapped.

- Before moving the crane, the C/O should have moved from the crane's control position to check the walkways and ensure the area directly below was clear.

- The crane was fitted with a warning bell and flashing amber light, but these only operated while it was moving. A pre-movement warning device would have alerted the 2/O to the crane's imminent movement.

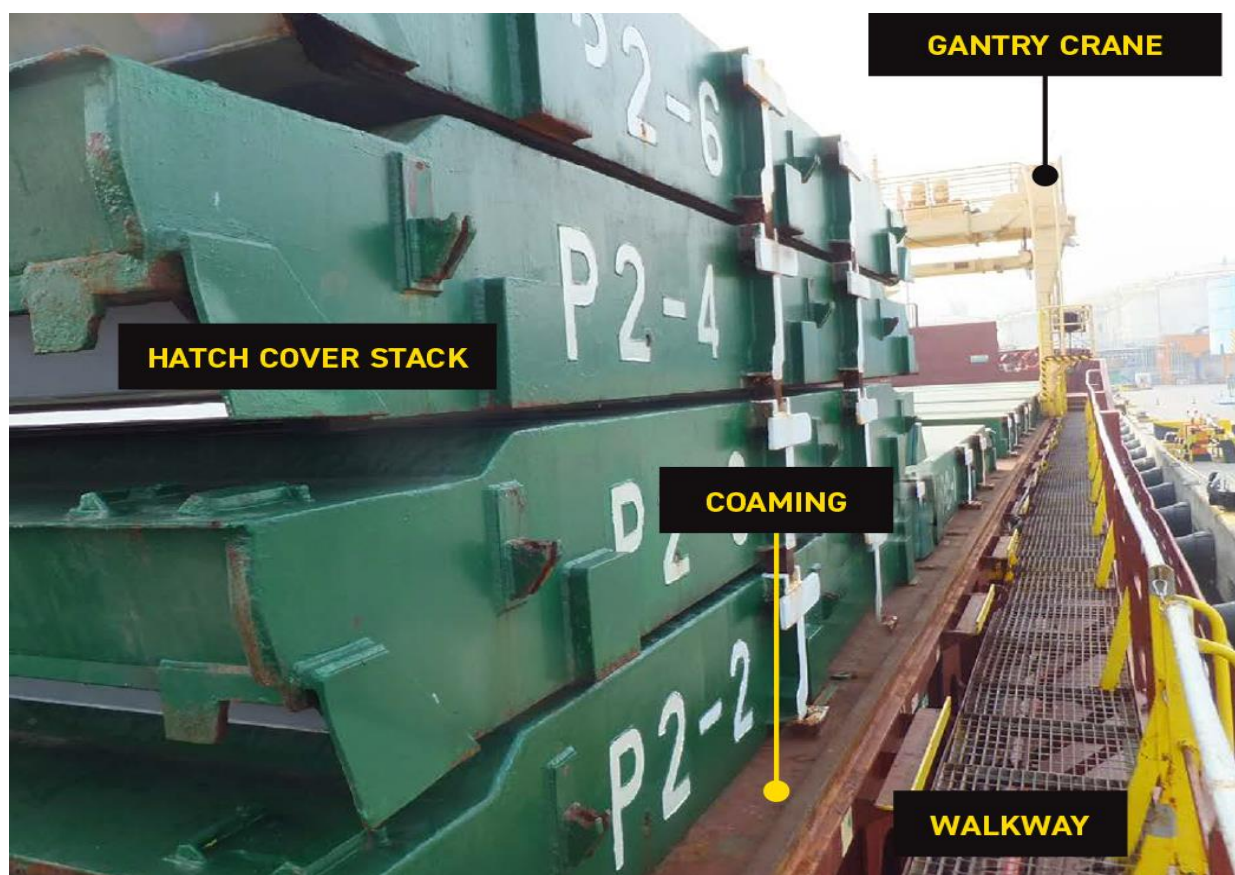
After 0830, the C/O started to lift and close the pontoon-type hatch covers using the ship's rail-mounted gantry crane (Figure 2) and instructed the deck crew to commence cleaning cement dust from the hatch

FIGURE 2 STARBOARD WALKWAY LOOKING FORWARD SHOWING STACK OF HATCH COVERS AND GANTRY CRANE.

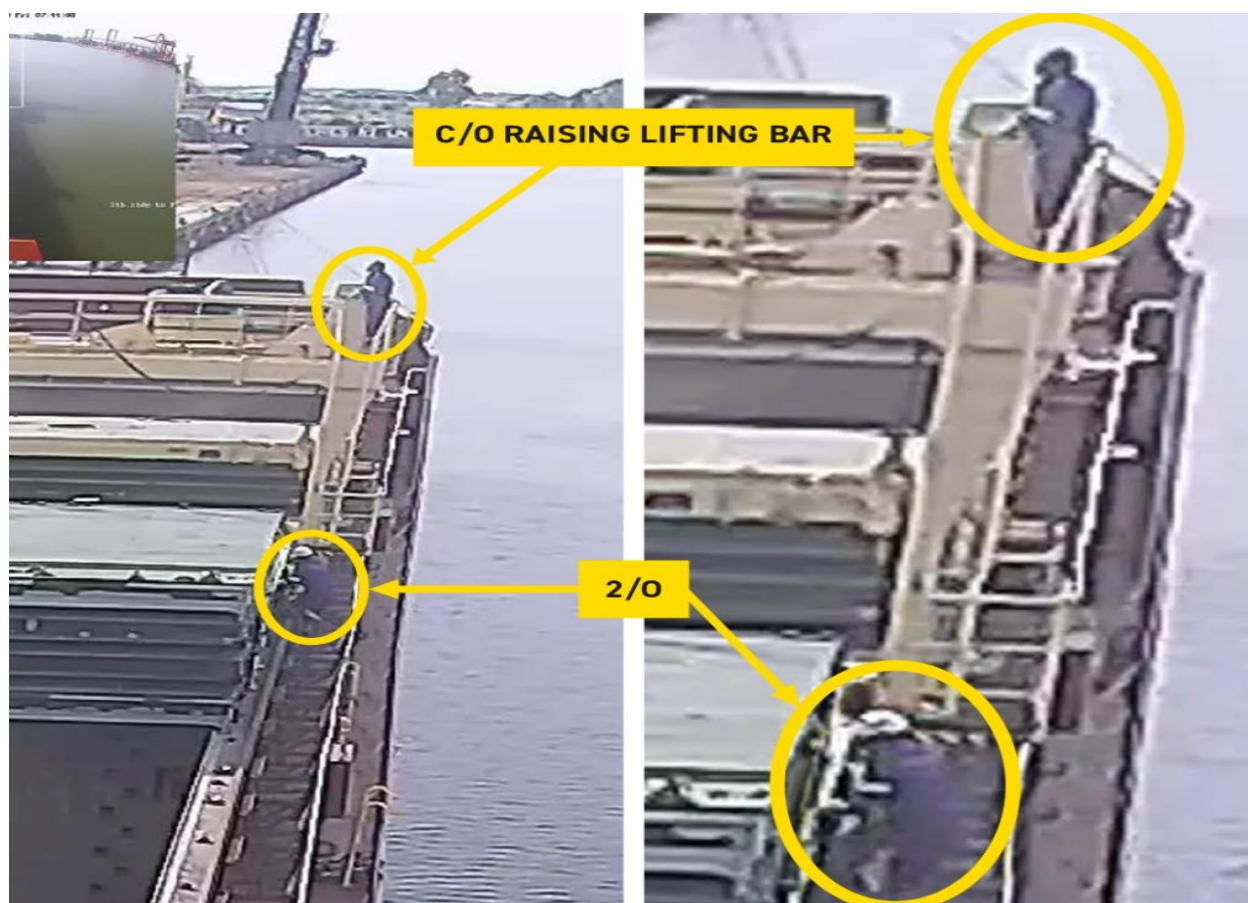
At 0942, the C/O moved a hatch cover to the forward end of the forward hold and lowered it into position and at 0943, he started to drive the gantry crane aft. At the same time, the 2/O finished sweeping and started to walk forward along the walkway. At 0944, the C/O stopped the crane just short of a stack of hatch covers at the forward end of the aft hold and started to raise the crane's lifting bar. At 0944:10, the 2/O arrived at the forward end of the hatch cover stack and climbed onto the hatch coaming (Figure 3).

**FIGURE 3** ZOOMED CLOSED-CIRCUIT TELEVISION (CCTV) SCREENSHOT LOOKING FORWARD SHOWING THE 2/O CLIMBING ONTO THE CARGO HOLD HATCH COAMING AT 0944:10.
