**Circular From WOE****Date: 27 July 2022**

## **Fitting and Removal of Temporary Lashing Points**

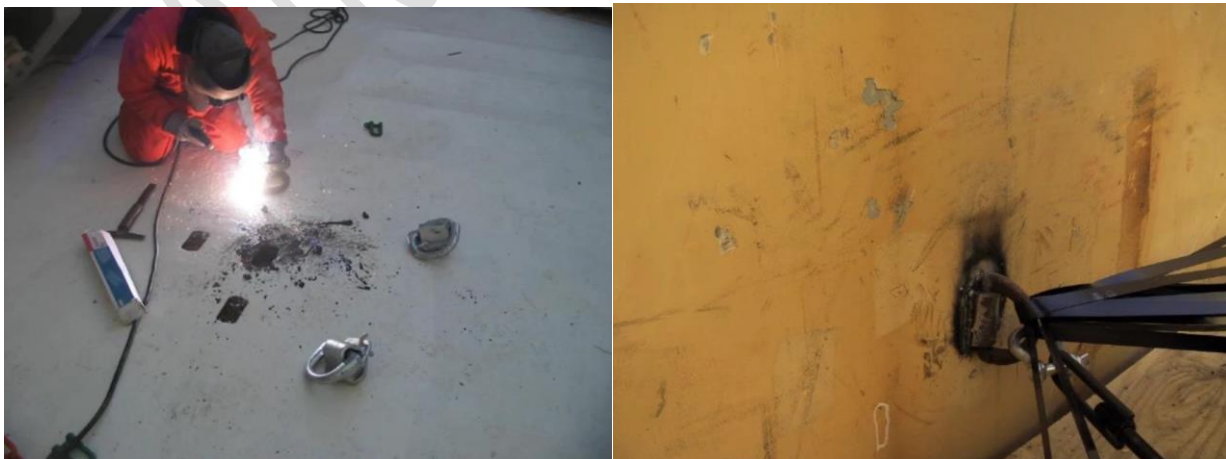
In some recent cases, hot slag/sparks have dropped into cargo holds and set fire to packaging or tarpaulins covering the cargo below. In addition to the direct fire damage, further damage to cargo has occurred due to water damage from subsequent firefighting operations.

In some cases, no fire watch had been arranged due to a lack of awareness that heat/sparks/slag can propagate through steel plating separating the point of work and cargo hold. In others, although a fire watch had been placed, it was not positioned correctly and/or there was too much reliance on fire retardant tape/blankets which were either poorly placed with no coverage at some points due to gaps or proved inadequate to deal with the high temperatures involved.

- Toolbox talks and hot work permits must be specific to the task at hand and recognise the risk of heat transfer/sparks/molten slag in all adjacent areas (above, below and to all sides), including cargo holds.

- Where protective coverings are used to protect cargo, they must be effectively placed and sufficiently robust – heavy duty welding blankets are readily available and should be used. More than one layer may be required. If possible hot work should only be made when holds are free of cargo.

- Oxy-acetylene cutting torches are frequently set to high pressure for fast cutting, leading to a wide spread of sparks and slag. Reducing the torch pressure can significantly lower the spread of sparks/slag, effectively reducing the risk, especially with a tight cargo stowage or when the securing points are within high-risk areas. Cutting will take longer, so it is important to explain this to those carrying out the works and for close oversight to be maintained throughout.

- Fire watches must be in place and need to be correctly located to see all possible hot zones. Watching for smoke from the hold entrance is not sufficient since the fire will already be well set at this stage.
