## Circular From Gard

Date: 7 July 2022

## Look out for fuel leaks and unshielded hot spots in engine rooms

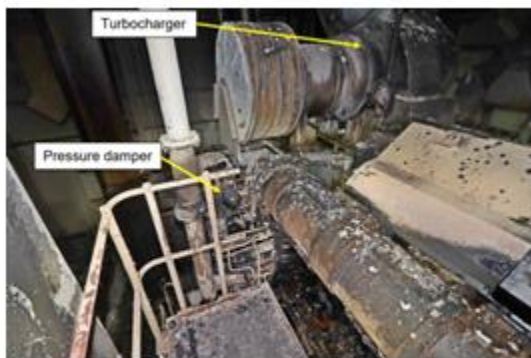
A copper pipe that was part of the fuel oil pressure gauge supply pipework for one of the auxiliary engines fractured. Due to a missing metal spray shield the fuel sprayed onto the unprotected hot surfaces of the nearby turbocharger and the exhaust system which had temperatures of more than 400 °C. The fuel ignited causing extensive damage to auxiliary engines and power distribution cables. The vessel was out of service

Fire damaged area of auxiliary engine

Referring to our initial case study above, making sure that the piping met the original specs, reinstalling the spray shield after maintenance, and using thermography to identify the exposed sections in the insulation around the turbocharger and exhaust manifold of the auxiliary engine would have prevented the fire from occurring.

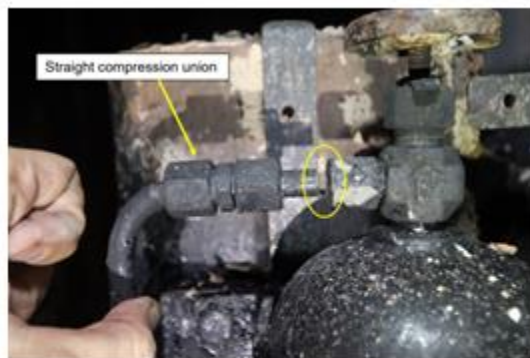
Investigation by experts showed that the copper pipe that fractured did not match the original design and had a lower wall thickness. There was no record of any previous repairs carried out to the fuel system pipework. The pipe assembly on the other three auxiliary engines appeared to be of original installation comprising of a steel pipe. The spray shield was removed during maintenance and not re-installed. Insulation was also suspected to be inadequate since exposed sections around the exhaust manifold and turbocharger were noticed on other three auxiliary engines. The investigators concluded that the heat shielding arrangements on the fire damaged auxiliary engine did not meet the relevant SOLAS regulations, II-2/2.2.6.1.

Fractured copper pipe

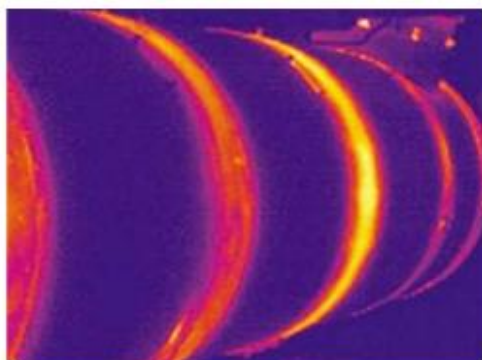
Thermo of the exhaust manifold of the main engine shows a max. temperature of 250°C.

Owners/managers can incorporate the use of thermography onboard for detection of hot surfaces and for checking insulation during normal operations. Owners should consider including thermographic examinations in newbuilding specifications and have such tests carried out during sea trials. A thermographic examination of the engine room and the vessel's electrical installation should be carried out periodically with engines and electrical equipment running.

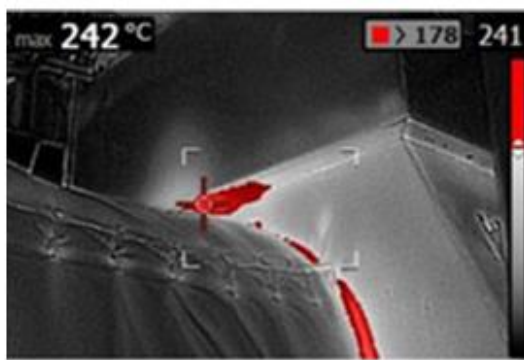
Exhaust manifold showing a max. tempetuare of 242°C.

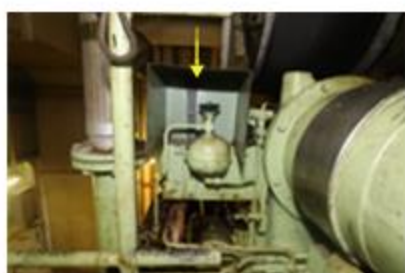
Spray shield around the pressure damper on auxiliary engine

**Spray shields:** The position and condition of spray shields for both high and low pressure flammable oil lines should be checked regularly, as should the drainage arrangements for jacketed fuel oil pipes. Where spray shields are not included in the original design and the area has been identified as a potential 'source of oil leakage' then the installation of spray shields should be considered. Particular attention should also be given to the immediate and proper refitting of spray shields and insulation materials upon completion of maintenance.

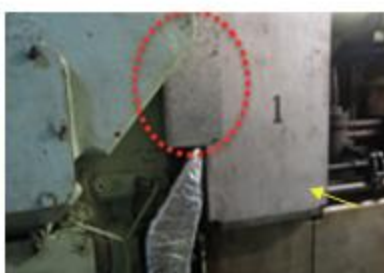
Shielding to protect the turbocharger
