Circular From GARD

Date: 8 August 2023

## Beware Cargoes Which May Liquefy Not Listed In The IMSBC

### Code

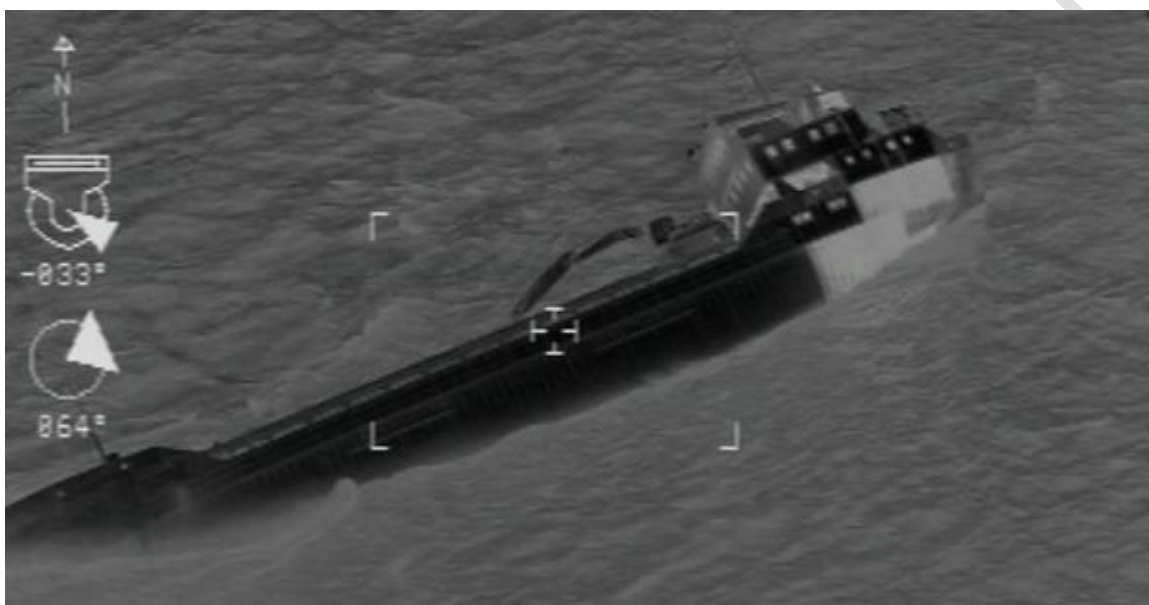
### Cargo of soil from a landfill

The vessel was transporting over 1,900 tonnes of soil, not listed in the IMSBC Code, from a landfill. During the voyage, the vessel was exposed to wind and waves causing the cargo to behave more like liquid cargo. The vessel listed and the five crew members were rescued before the vessel eventually sank. The authorities ordered the removal of oil from the wreck, which was otherwise not considered to pose a danger to navigation. The case was the subject of an investigation by the Norwegian Safety Investigation Authority (NSIA). The NSIA considered it likely that there was moisture in part of the stockpile and thereby in the soil that was taken on board.

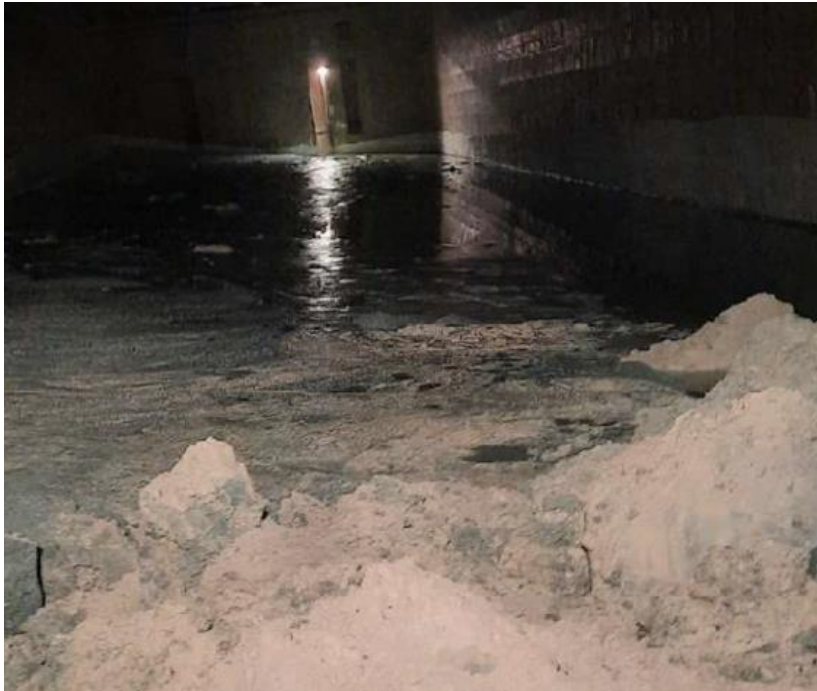
### **Cargo of calcium carbonate**

In another case, the vessel developed a list shortly after leaving load port. Fortunately, the crew were able to get the ship to a sheltered anchorage. Upon inspection the cargo had mostly levelled and there was water on top of it. Salvors removed the free water and the vessel was towed to a nearby port where the cargo was discharged.

The cargo in this case was Calcium Carbonate, which is not specifically listed in the IMSBC Code. Limestone, which is also calcium carbonate, is listed as being a Group C. Calcium Fluoride, Calcium Sulphate and Calcium Carbonate mixture is identified on page 493 of the 2022 version of the Code as being Group A.

The cargo had been stored on the quay as an open stockpile, subject to snow showers before and during loading. The Chief Officer inspected the stockpile and noted that the consistency was between clay and sand and that it was partly frozen. After checking the Code and seeing that the cargo was not listed, the Master requested further information from charterers and was advised the cargo was not dangerous. No can tests were therefore conducted by the crew prior to loading. Can-tests performed on the cargo after the incident, and therefore after free water had been removed from the top of the stow, indicated the “possibility of flow” as described in Section 8 of the IMSBC Code.

The shippers confirmed that the cargo had not been tested for flow characteristics. Laboratory testing of cargo samples later confirmed the cargo to be Group A and unsafe for carriage. It had a moisture content over 30%, exceeding both the TML of 24% and Flow Moisture Point (FMP) of 26.7%. The TML of a cargo which may liquefy is set at 90% of the FMP and is the maximum moisture content of the cargo which is considered safe for carriage. It is determined by test procedures, approved by a competent authority, such as those specified in paragraph 1 of appendix 2 of the IMSBC Code. Particle size distribution (PSD) analysis also revealed the material to entirely consist of particles less than 2mm.
