Circular From GARD

## China - Aquaculture Farming Presents a Challenge to Navigation

**Vessels calling at Lanshan Port, China are advised to proceed with caution as the number of marine installations associated with aquaculture farming is growing.**

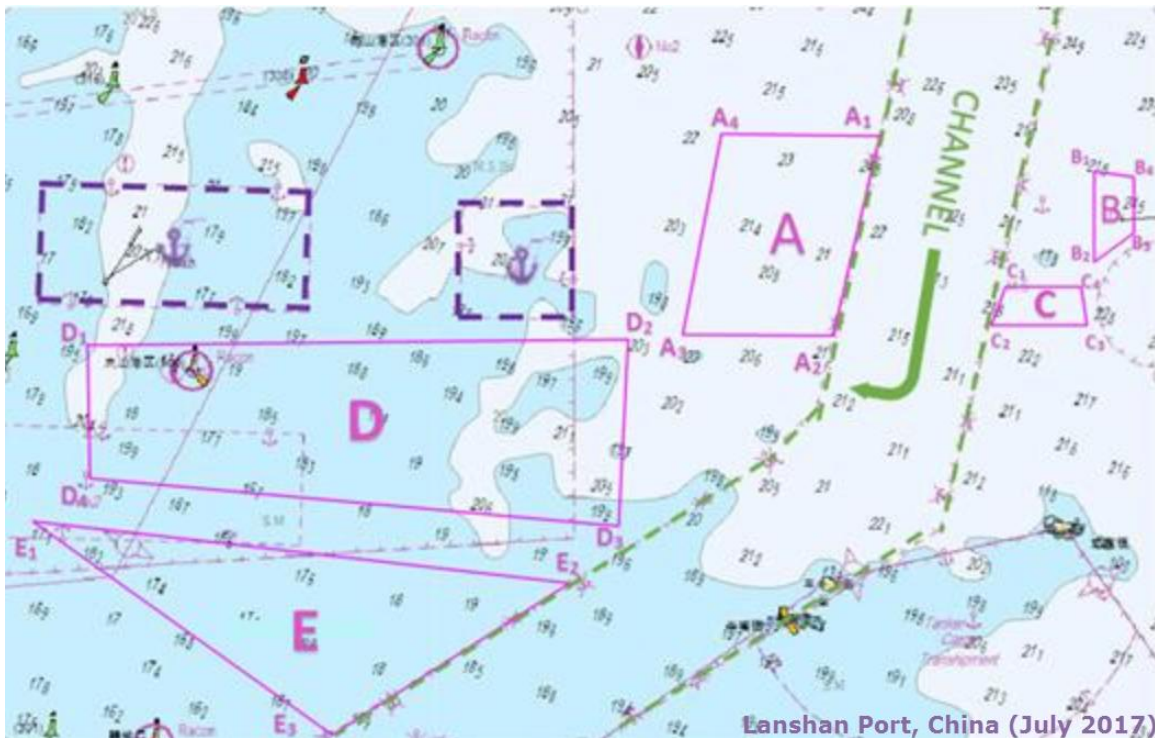
Gard's correspondent Huatai Insurance Agency & Consultant Service Ltd. published its circular No. PNI 1706 on 21 July 2017. The correspondent identifies five aquaculture farms near Lanshan Port which are located very close to the navigation channel but which are not marked on charts. These are marked as A, B, C, D and E in the illustration below. Three of the farms, A, B and C, were established only in the last two years.

A copy of Huatai Circular No. PNI 1706 is available [here](#). It lists the coordinates of the farm locations and provides recommendations on how to avoid incidents when navigating the waters in question.

Members and clients trading to China are recommended to forward a copy of Huatai Circular No. [PNI 1706](#) to all vessels calling at Lanshan Port and to instruct the duty officer onboard to plot the location of the aquaculture farms on the relevant charts. However, as the number and extent of farms may change, Masters of such vessels should:

- seek advice well in advance of arrival concerning the current siting of aquaculture farms, not only from local agents but also from Gard's correspondents, VTS and the local MSA;
- maintain a proper lookout and consider positioning an extra lookout on the forecabin;
- navigate with caution and do not deviate from the defined channel; and
- proceed at a speed appropriate to these confined and congested waters.
